REINFORCING TAPE SOLVES ACCESS HOLE TEARING PROBLEM

BY TIM LAMIE, ADALIS

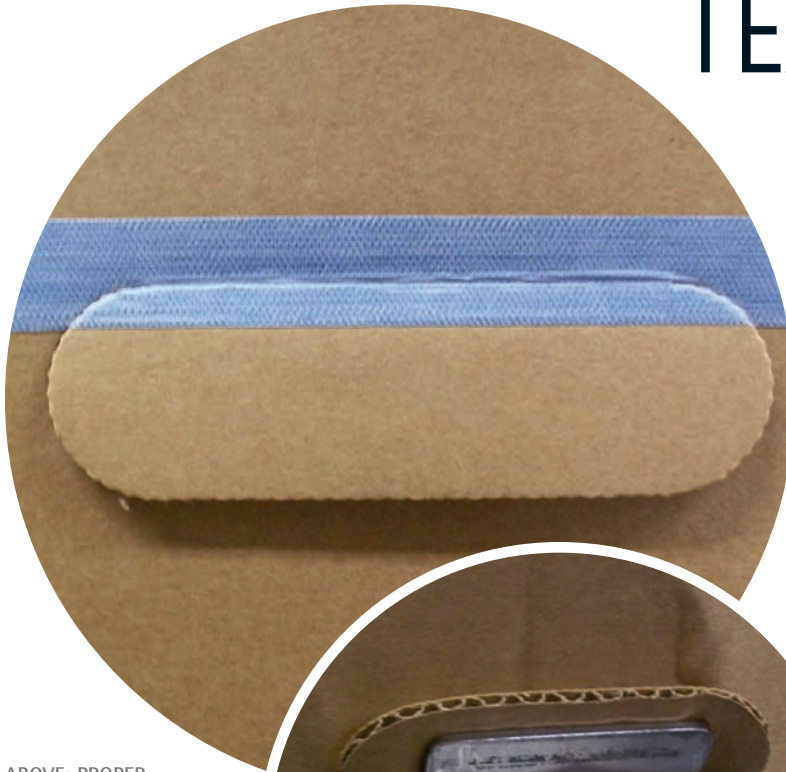
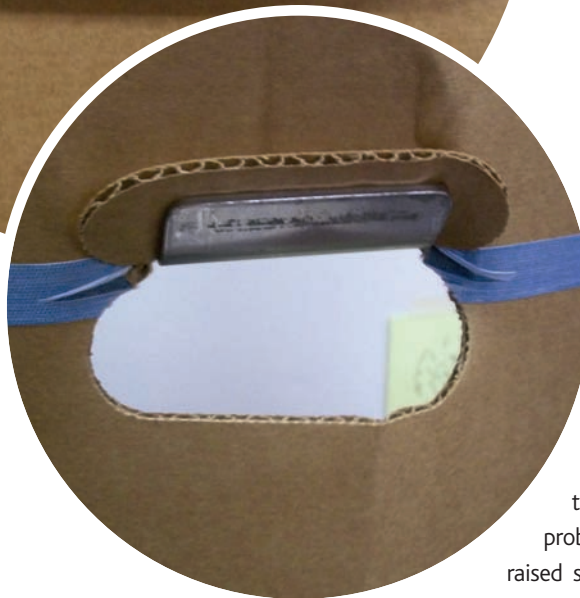
ABOVE: PROPER PLACEMENT OF TAPE IN RELATION TO THE ACCESS HOLE IS CRITICAL TO THE EFFECTIVENESS. RIGHT: EVEN THOUGH THE TAPE REINFORCEMENT IS NEAR PEAK LOAD, THE STRESS ON THE ACCESS HOLE HAS NOT TORN THROUGH THE CORRUGATED.

While it may be counter intuitive, diecutting the access hole partially into the tape actually makes the access hole stronger. Through years of experience, Adalis has proven that performance of access holes is a combination of tape selection, tape placement and type/style of access hole. Cutting the hole a fraction into the tape during the finishing process improves the strength of the access hole rather than simply diecutting the hole below the tape. For each application, Adalis can help determine the ideal amount that the tape should be cut into and help with proper tape placement.

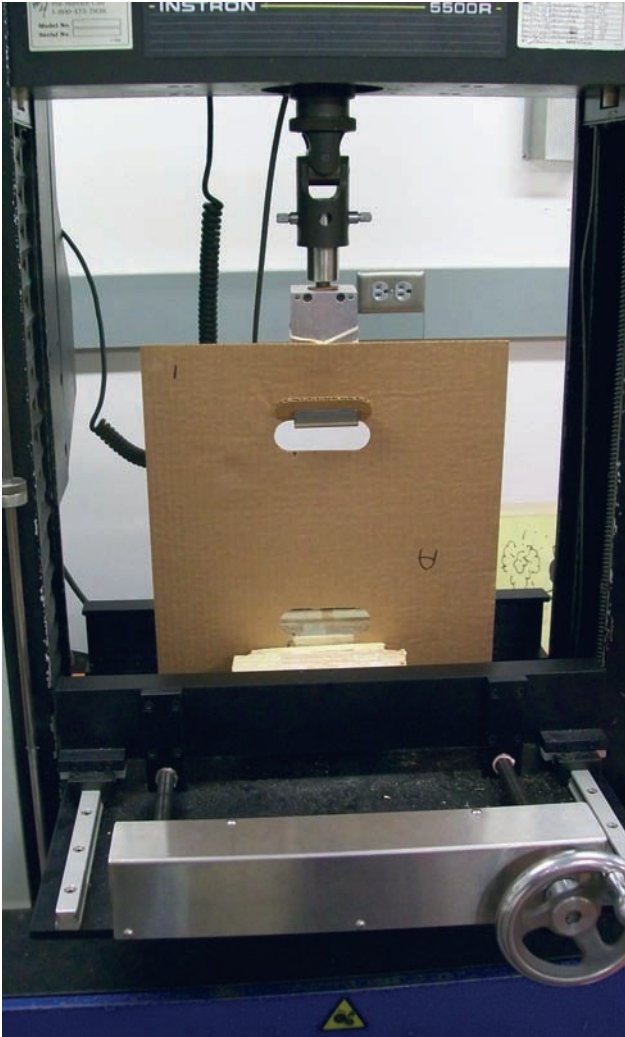
THE REINFORCED AND NON-REINFORCED ACCESS HOLES WERE PULLED IN AN UPWARD, VERTICAL DIRECTION, USING A CURVED HANDLE.

One combination had a tape adhered between the doubleface liner and singleface medium. The other option had the tape bonded to the exterior surface of the singleface liner. Control samples without any reinforcement tape were cut for each board combination as well. The samples were conditioned and tested to measure the maximum force required to break or tear the access hole.

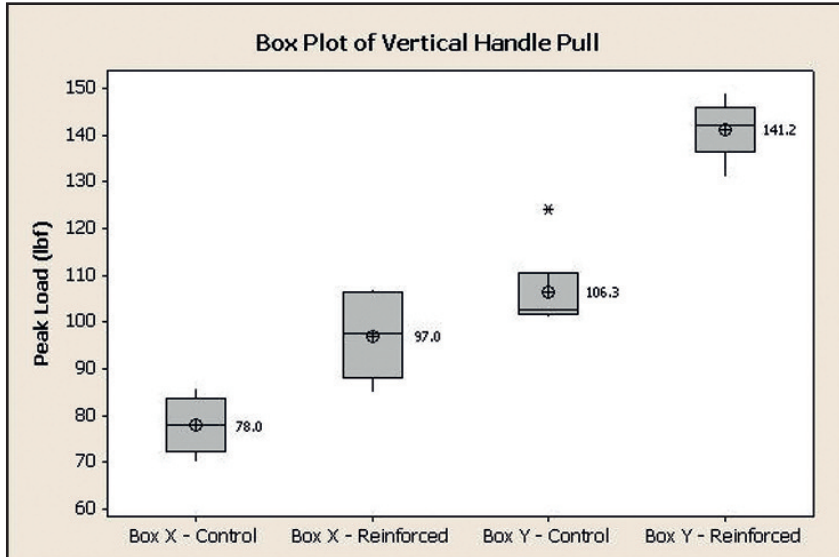
ADALIS WORKED WITH THE BOX MANUFACTURER TO TEST DIFFERENT LINERBOARD COMBINATIONS AND TAPE VARIETIES TO SEE WHICH WOULD PROVIDE THE OPTIMUM STRENGTH FOR THE ACCESS HOLE.

board. The tests showed a 33% improvement in the access hole compared to the current box and provides a strength safety factor of 5.5.
